6.0 Grand Junction, Colorado, Disposal Site

6.1 Compliance Summary

The Grand Junction, Colorado, Uranium Mill Tailings Radiation Control Act (UMTRCA) Title I Disposal Site, was inspected on March 21 and 26, 2008. The disposal cell and all associated surface water diversion and drainage structures were in good condition and functioning as designed. A portion of the disposal cell remains open and is operated by DOE to receive additional low-level radioactive waste materials from various sources. The annual inspection requirement is only applicable to the closed and completed portion of the disposal cell and the surrounding disposal site.

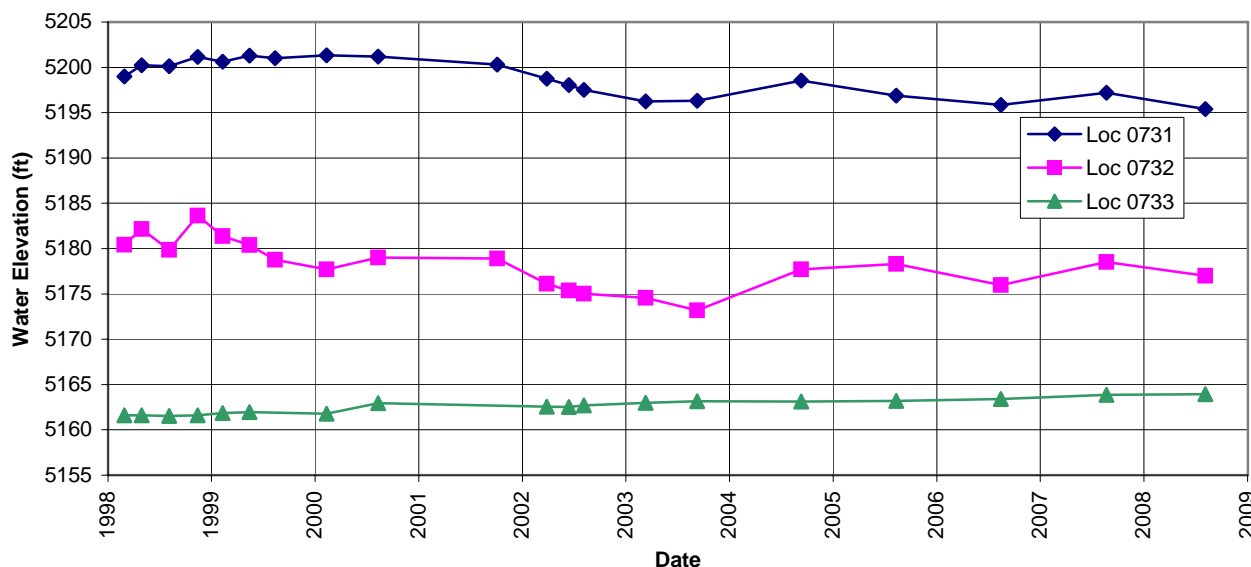
Figure 6–2. Water-Level Measurements at the Grand Junction Disposal Site

The water level in the disposal cell well MW-0733 has displayed a persistent rise of approximately 2.5 feet since 1998. Since 1998, the water level in the disposal cell well MW-0733 has remained significantly deeper than water levels in the two paleochannels wells MW-0731 and MW-0732 (Figure 6-2). Water levels within the two paleochannels at wells MW-0731 and MW-0732 have displayed a decrease of approximately 3 to 4 feet since 1998; although, this decrease is more varied and larger than which has occurred in well MW-0733. In 2008, water levels in these wells MW-0731 and MW-0732 continued the downward trend. Based on this information, there currently is no potential for groundwater at the base of the disposal cell at well MW-0733 to migrate to the paleochannels at wells MW-0731 and MW-0732.

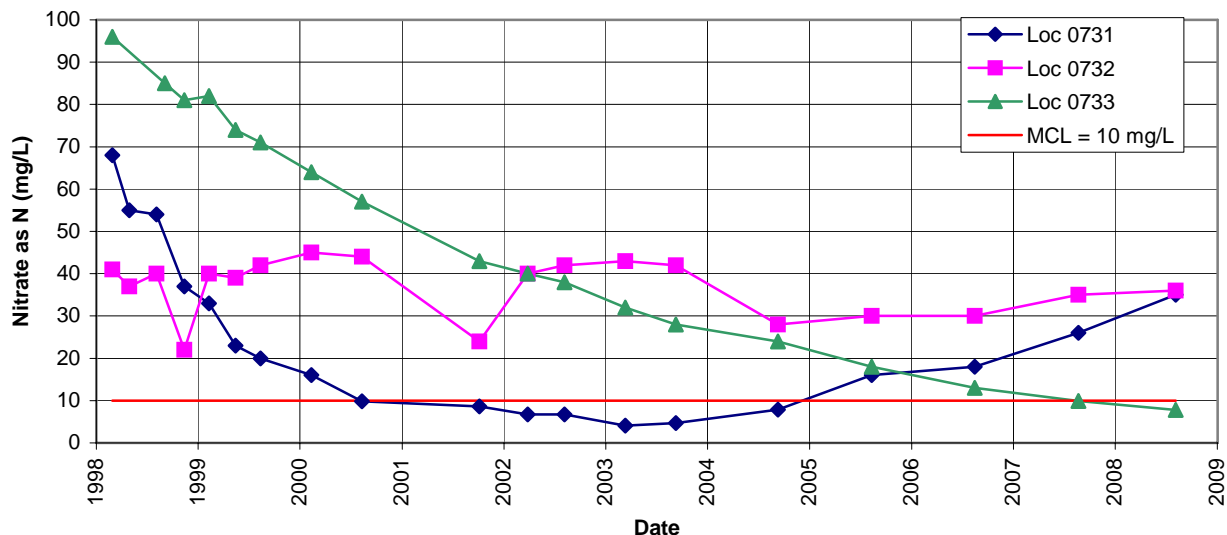
Figure 6-3. Time-Concentration Plots of Nitrate (as Nitrogen) in Groundwater at the Grand Junction Disposal Site

Nitrate (as nitrogen) concentrations in groundwater continued to exceed the MCL of 10 mg/L in the paleochannel monitor wells (MW–0731 and MW–0732) through 2008 (Figure 6–3).

Concentrations in well MW–0731, following an initial steep downward trend, remained below the MCL from 2000 through 2004. In 2005, and continuing through 2008, concentrations were steadily increasing above the MCL. Concentrations in well MW–0732, although varied, have

consistently remained above the MCL since 1998. Concentrations in well MW-0733 continued a significant downward trend, dropping below the MCL in 2006, and reaching a historical low of 7.8 mg/L in 2008. Historically, the highest concentration of nitrate (96 mg/L) occurred in 1998 from the disposal cell well MW-0733. In 2008, the highest concentration of nitrate, 36 mg/L, occurred in paleochannel well MW-0732.

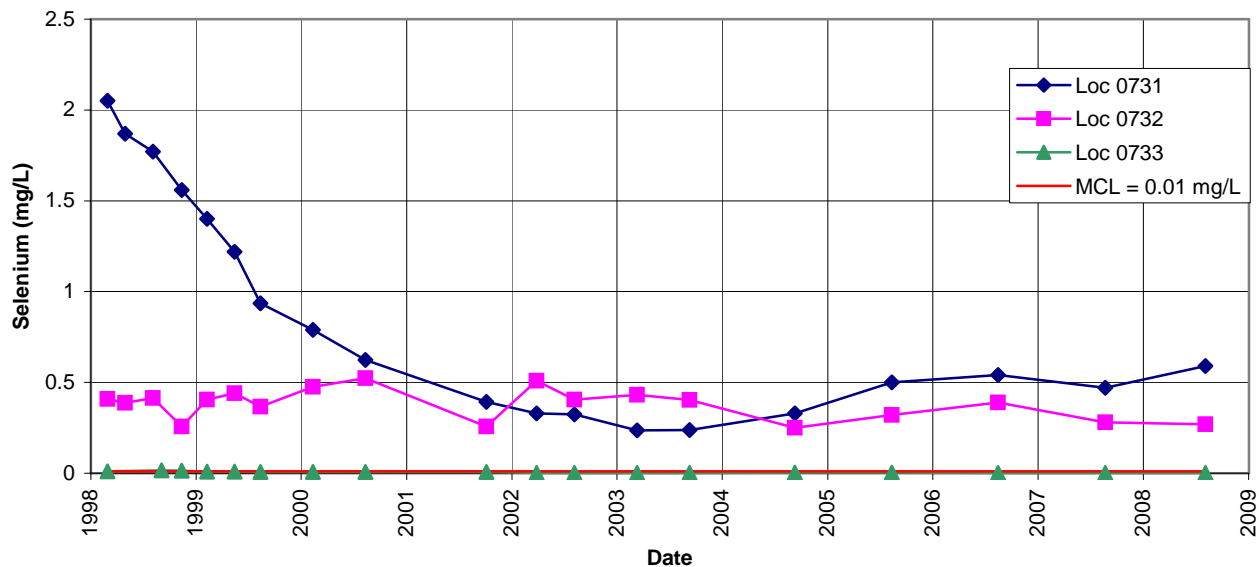
Figure 6-4. Time-Concentration Plots of Selenium in Groundwater at the Grand Junction Disposal Site

Selenium occurs naturally in the Mancos Shale deposits that underlie the disposal cell and may be the cause of the elevated concentrations reported in both paleochannel monitor wells MW-0731 and MW-0732. Selenium concentrations continued to exceed the MCL of 0.01 mg/L in the paleochannel wells (Figure 6-4). Concentrations in well MW-0731 displayed a sharp decreasing trend, with the decreasing trend continuing until 2003, at which time a slight upward trend began. In 2008, concentrations in well MW-0731 continued to increase (approximately 0.1 mg/L). Concentrations in well MW-0732, although more variable than wells MW-0731 and MW-0733, continue to display no trend. In well MW-0733, the selenium concentration of 0.0025 mg/L remained well below the standard, with no trend evident. In 2008, the highest concentration of selenium, 0.59 mg/L, occurred in paleochannel well MW-0731.

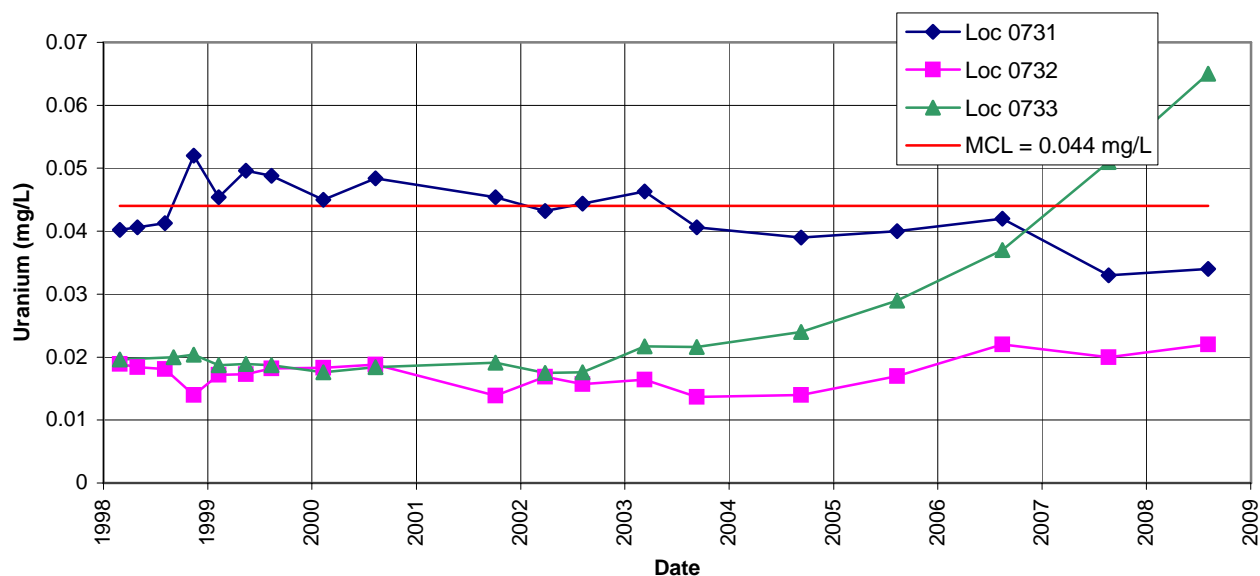
Figure 6–5. Time-Concentration Plots of Uranium in Groundwater at the Grand Junction Disposal Site

Uranium concentrations in groundwater were below the MCL of 0.044 mg/L in samples from the two paleochannel wells MW-0731 and MW-0732, but were reported above the MCL in well MW-0733 (0.065 mg/L) for the second consecutive time (Figure 6-5). Concentrations in well MW-0731, after an initial increase, have displayed a decreasing trend that continued in 2008. Concentrations in wells MW-0732 and MW-0733 remained relatively consistent through 2003, at which time an upward trend began in both wells, which continues to be much more pronounced in well MW-0733.

The elevated uranium in MW-0733 pose no risk to human health or the environment because the disposal cell is situated on a thick aquiclude overlying limited use groundwater that is not for any purpose.

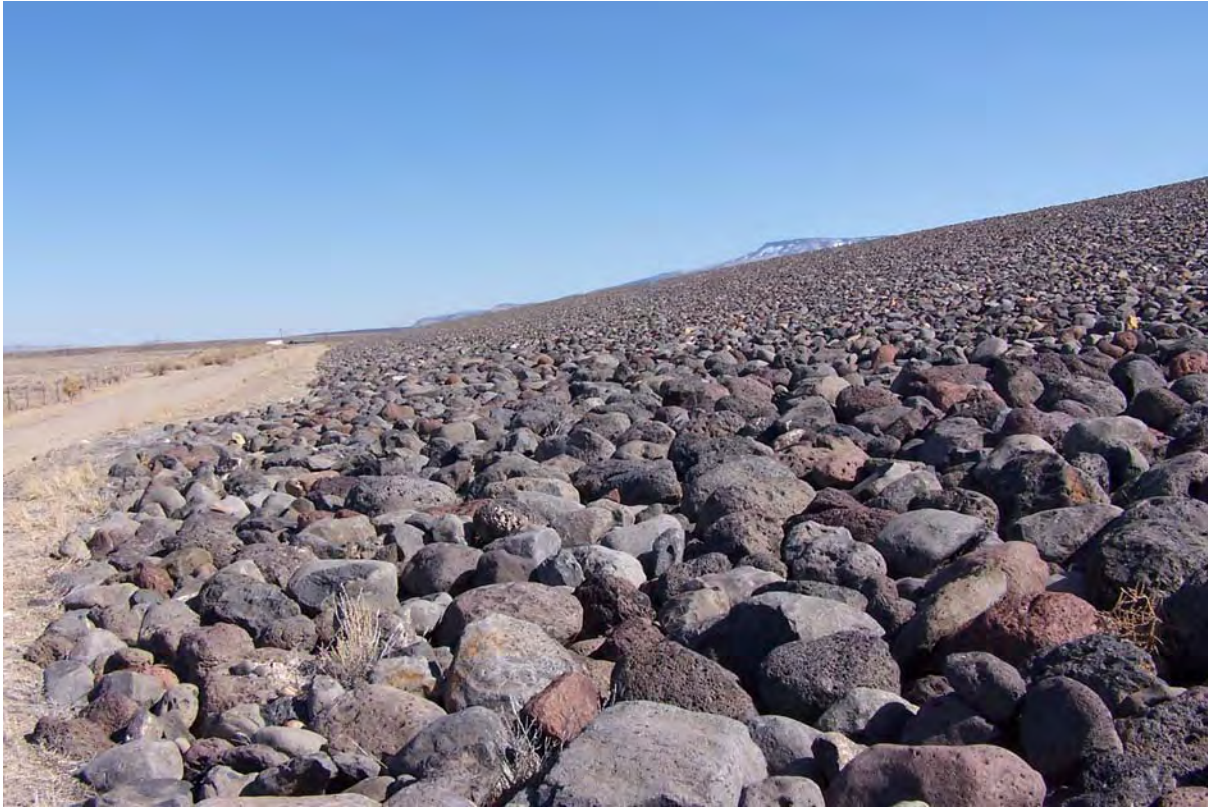
Closed Portion of the Disposal Cell—The top and side slopes of the disposal cell are covered with basalt riprap. The rock is durable and in excellent condition. There is no evidence of slope instability, and very little plant encroachment is occurring on the side slopes (PL-1).

GRJ 3/2008. PL-1. View north along the west side slope of the disposal cell.

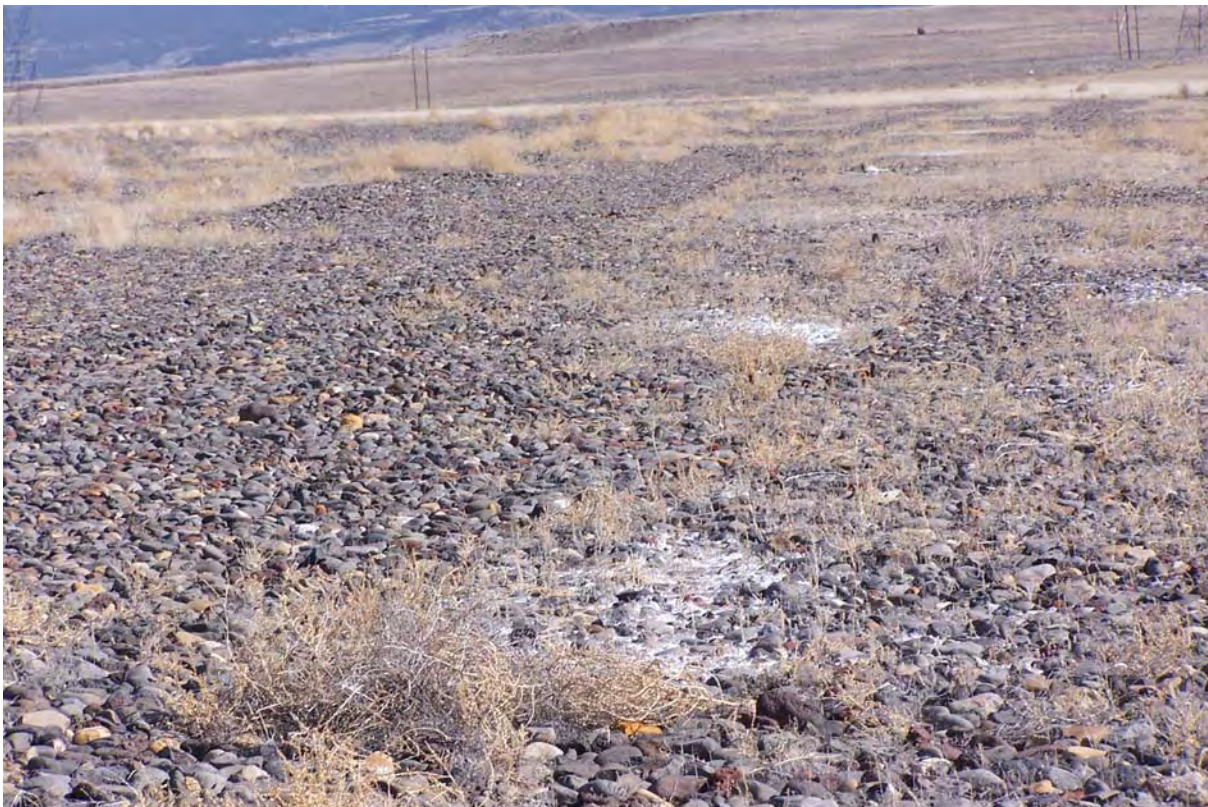
Runoff drains toward the southeast corner of the cell. Several small areas with evaporite deposits are present on the cover near the southeast corner (PL-2). There was no evidence of settling or erosion of the cell cover, so these features are not a concern.

GRJ 3/2008. PL-2. Alkali area near the southeast corner of the disposal cell top.

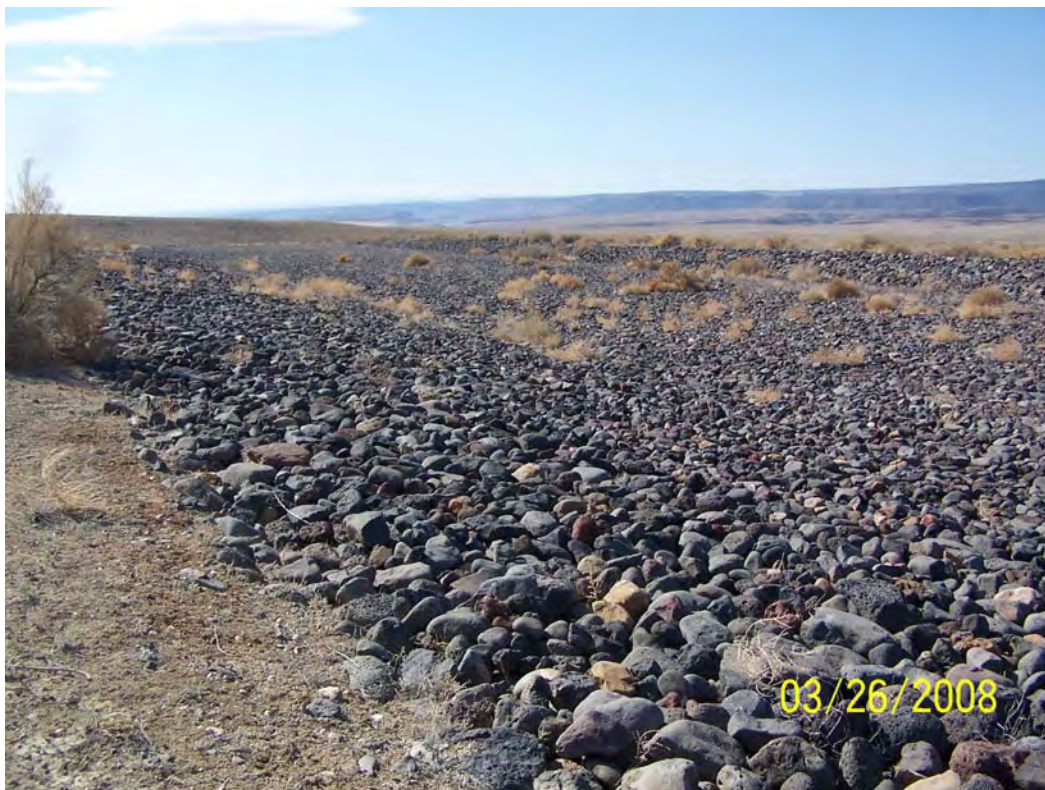
Diversion Structures and Drainage Channels—The south diversion channel is a large riprap-armored structure that conveys runoff water from the disposal cell southeast into a natural drainage that flows away from the site to the southwest. The diversion channel is in excellent condition. Some plant growth, including grasses, weeds, and deep-rooted shrubs, exists within the channel (PL-3). However, there is not enough growth to impede water flow within the channel. Erosional features at the outfall of the channel are self-armoring with large riprap boulders and are stable. An area of active erosion east of the outfall area continues to be monitored, but no surveillance features are threatened, and the area is expected to stabilize.

GRJ 3/2008. PL-3. View down slope along the south diversion channel.

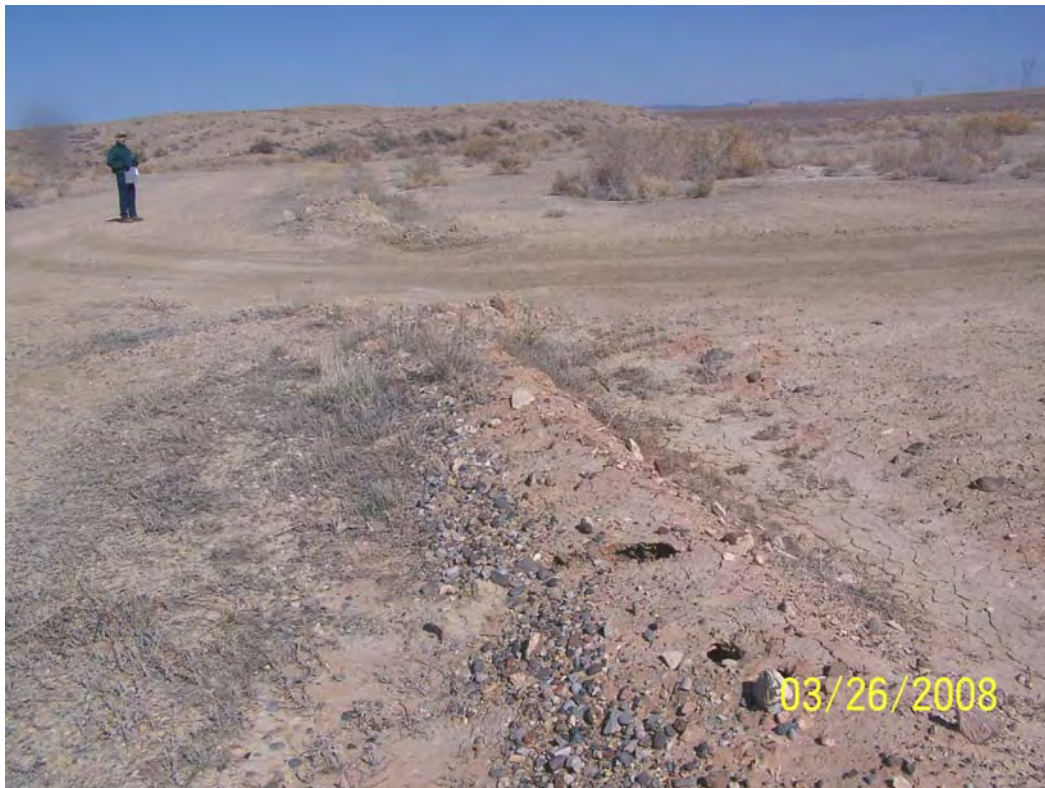
6C Other drainage features at the site include north and south storm water collection ditches, the north storm water retention pond, and a storm water and sediment collection pond on the east side of the south diversion channel. These small drainage features control storm water runoff primarily from the various cover materials stockpiled on the northern and eastern portions of the disposal site property. The north storm water collection ditch also captures run-on storm water from a large catchment area north and east of the disposal site. The south storm water collection ditch was filled in at one location when access to the clay stockpile was needed. In 2008, this location on the ditch was repaired to restore its drainage function (PL-4). Accumulated sediment was also removed from the storm water and sediment collection pond. The ditches and ponds are functioning as designed.

GRJ 3/2008. PL-4. Storm water drainage ditch between the south diversion channel and the clay stockpile.

In 2008, DOE performed the following maintenance at the site: A portion of the south storm water collection ditch was repaired to restore its drainage function. Accumulated sediment was removed from the storm water and sediment collection pond. Tamarisk was cut and treated with herbicide. Perimeter signs P17 and P27 were replaced.
